# *M/V Cosco Busan:* Incident Overview & Incident Specific Preparedness Review

Steve Lehmann  
Scientific Support Coordinator, New England  
National Oceanic & Atmospheric Administration

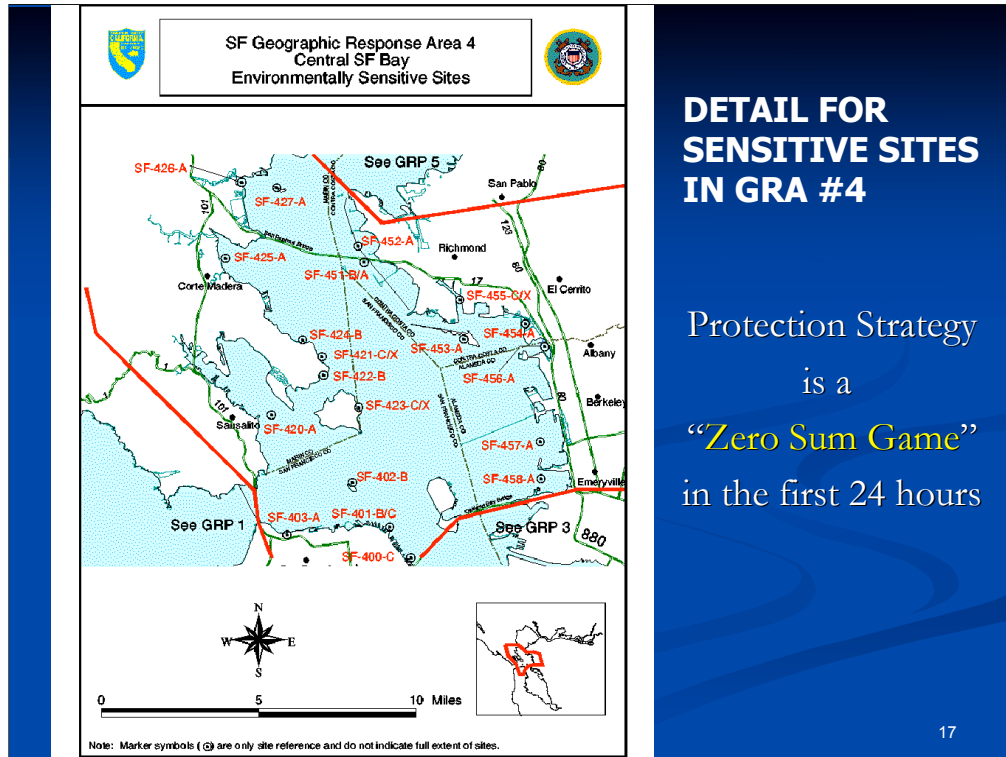
This is an example GRA in SF Bay. Each dot with a number represents a different sensitive site. The letter following the number conveys protection priority. For example, near the Chevron Long Wharf in Richmond is Site 451 – B/A called “Castro Rocks”. This site is a B priority for most of the year except during the spring months it is an A priority site because of harbor seal reproduction.

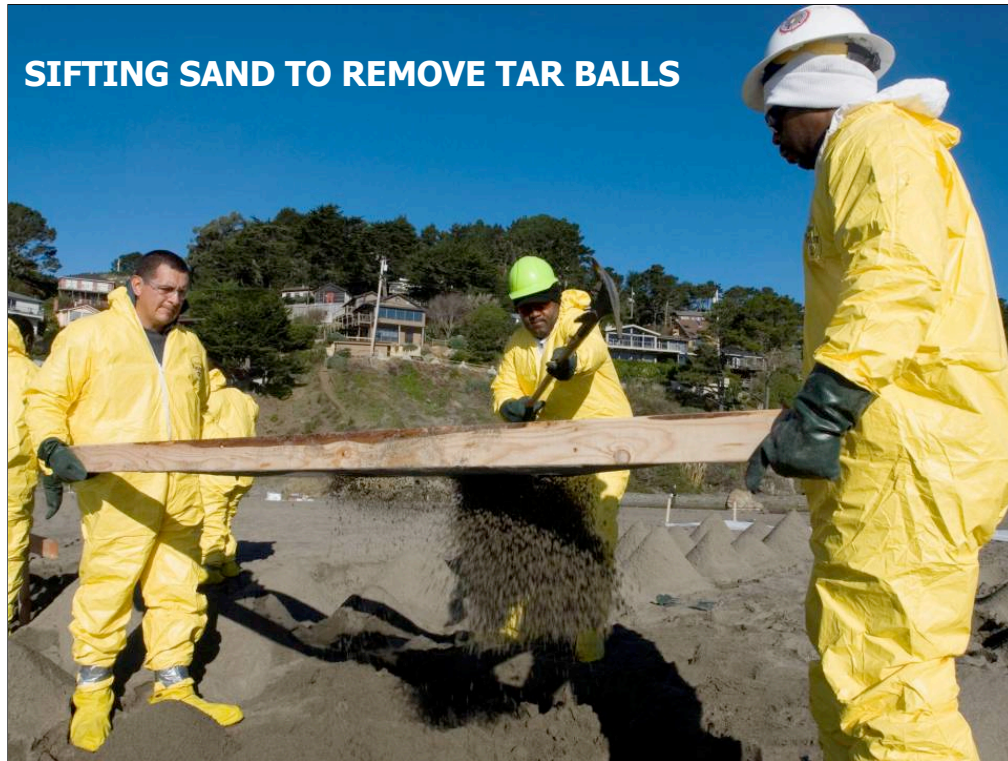
Sift box shows the care that was taken in cleaning the beaches. Point out the cone-shaped piles in the background showing where they have already sifted.

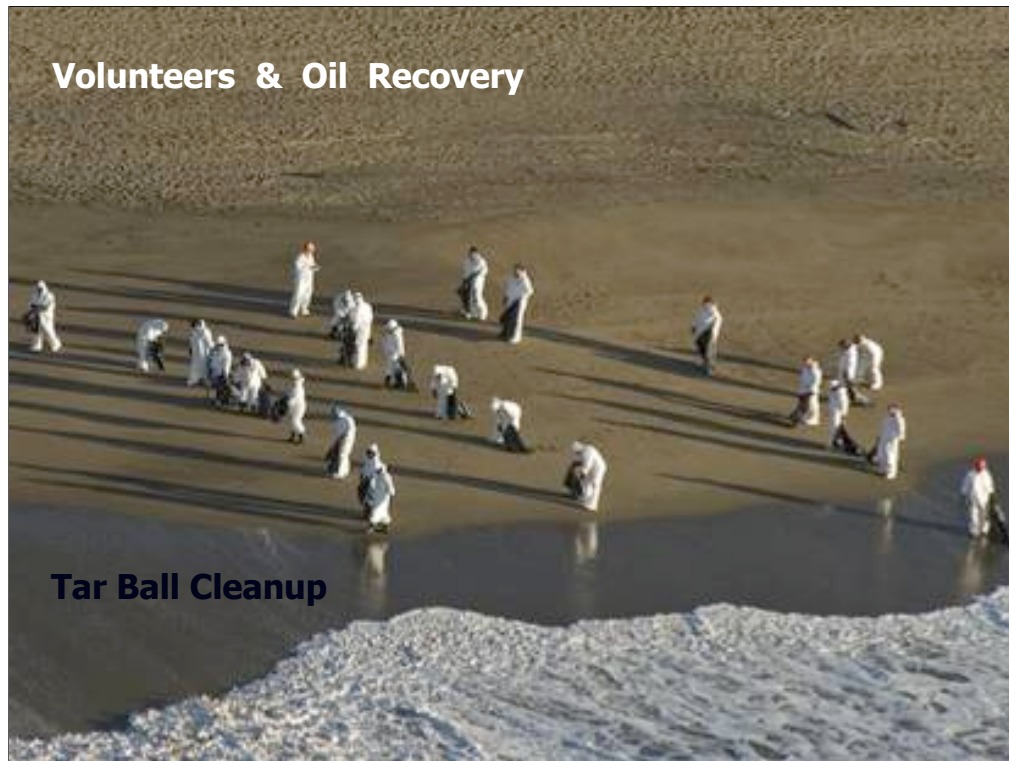
- Here is an outer-coast beach cleanup operation.
- The numerous workers you see here are pre-trained certified personnel.
- You can see that they are conducting a systematic clean-up operation and are wearing the proper personal protective gear.
- There are guidelines for the proper disposal of the protective gear and the waste which were closely followed throughout the cleanup operations.
